**NEA/CNRA/R(2012)2**

**NUCLEAR ENERGY AGENCY  
COMMITTEE ON NUCLEAR REGULATORY ACTIVITIES**

**First Construction Experience Synthesis Report  
2008-2011**

**Working Group on the Regulation of New Reactors (WGRNR)**

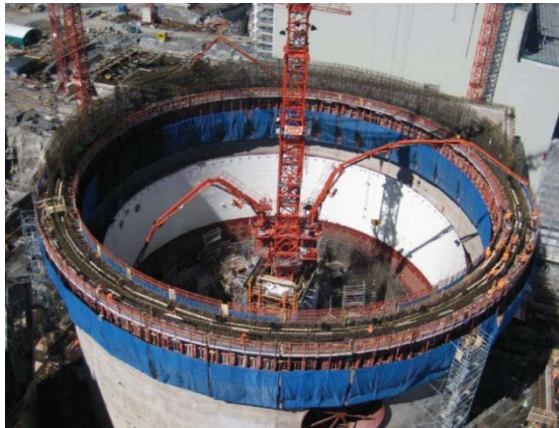
In Olkiluoto-3 in June 2007 following welding of the steel liner some imperfections were detected that exceeded the acceptance criteria.

The direct cause of the poor quality of the welding was the change in the welding environment (wetting of the concreted area nearby causing extra humidity) and human error of the welders.

The licensee corrected the deficiency by replacing parts of the liner by new steel plates (sized at 0.5 m<sup>2</sup> average).

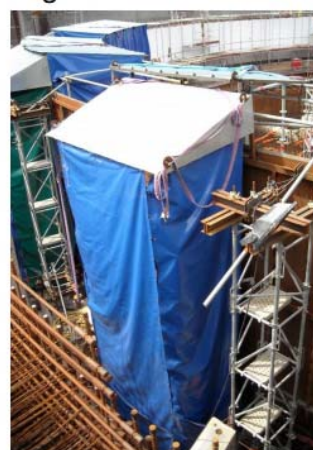
In June 2008 at Flamanville-3 the licensee, after several questions raised by ASN about the welding activities on the liner, decided to stop all welding activities. That same month an inspection by ASN found that the welding processes used were not permitted by the construction code. ASN required a justification for the lack of compliance with the construction code to ensure the quality of the liner in such conditions.

In the following months ASN detected an excessive number of repairs (especially on the reactor building basemat area), they found inadequate consideration of adverse environmental conditions (water, wind, etc.), and required the licensee to demonstrate the quality of the liner welds and to define preventive actions to reduce the repair or rework rate of welds. As a response to this, the licensee submitted a report that concluded that the defects were due to gas cavity, inclusion, and only 4% of the defects due to lack of fusion, wormhole, etc. It also indicated that the repair rate in the reactor basemat area was between 13% to 34% while this same figure in the prefabrication area was between 5% and 15%.

The direct cause of these events was poor manual welding, worsened due to the bad weather conditions. The automatic process was not possible in the environmental conditions of the building site.

The main actions taken by the licensee were to develop suitable protection of the welding areas to improve the environmental conditions, reinforcing the control of its subcontractors and performing a 100% radiographic test of the liner welds.

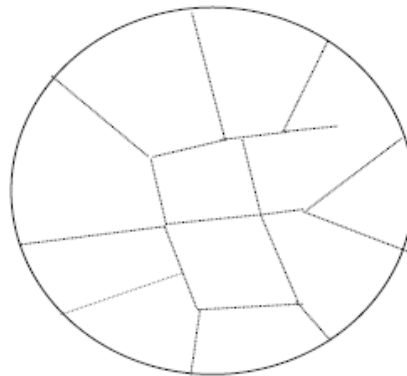
Configuration of cracks in the circular basemat

In Flamanville-3 in January 2008 the licensee reported to the ASN the appearance of cracks in the poured concrete basemat of the reactor building. The transverse cracks ran the full depth of the first layer for the reactor building basemat (1.75m - 4200 m<sup>2</sup>). The biggest cracks were 3.5 mm wide, but as time went on, the licensee observed that the width of the cracks were decreasing. The pouring activities of the second layer of the basemat were deferred by the licensee to wait for the conclusions of the assessment performed by ASN and IRSN on this non-conformity.

The direct cause was the lack of steelwork reinforcement at the level where pouring was stopped.

The main safety consequence of this deficiency is the impact on the mechanical strength of the basemat.

Immediately after the discovery of the deficiency, the licensee treated the cracks by filling them with epoxy resin under pressure to protect the exposed steelwork and close ground water paths. Also, the licensee demonstrated to the ASN that by applying this resin there would be no loss of mechanical strength and that the basemat would be leak tight against underground water.

As a preventive action, the licensee has adopted the appropriate pouring strategy (i.e. improving the concrete formulation) to minimize cracks.

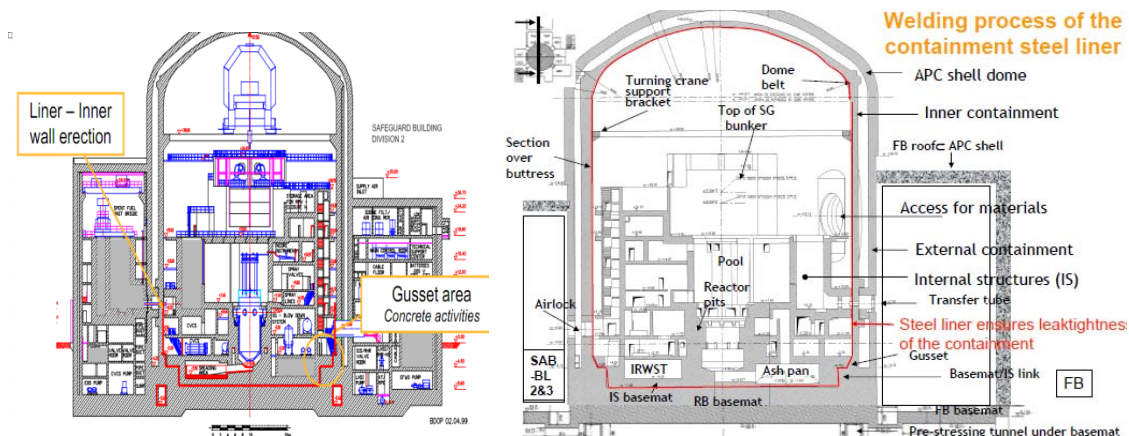
In October 2008 the licensee’s procedure for the concrete pouring of the gusset area considered two concreting lifts without joint treatment. The installation of the steel reinforcement of the gusset area without the joint treatment is not in compliance with the construction code ETC-C.

The safety consequence of this deficiency is a potential loss of the mechanical strength of the gusset and also a loss of the leak tightness of the barrier.

According to the ASN, the root cause of this event was the lack of preparedness and planning of the licensee and its contractors to perform safety-related activities.

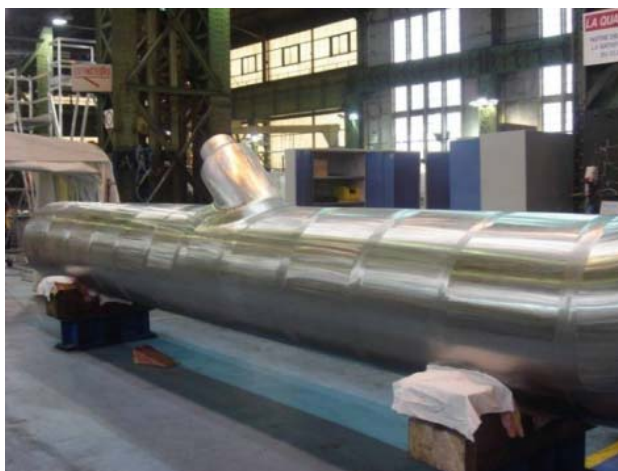
##### - *Inhomogeneous grain size*

In Olkiluoto-3 the main coolant lines (Hot and Cold Legs) of the primary circuit are manufactured from large forgings to minimize the number of welds. Tests performed on the main coolant line forgings revealed coarse and inhomogeneous grain size areas in the forgings. In addition, tensile and hot tensile strength values were somewhat too low for some forgings. Grain size exceeded the criterion which was specified in the Preliminary Safety Analysis Report (PSAR).

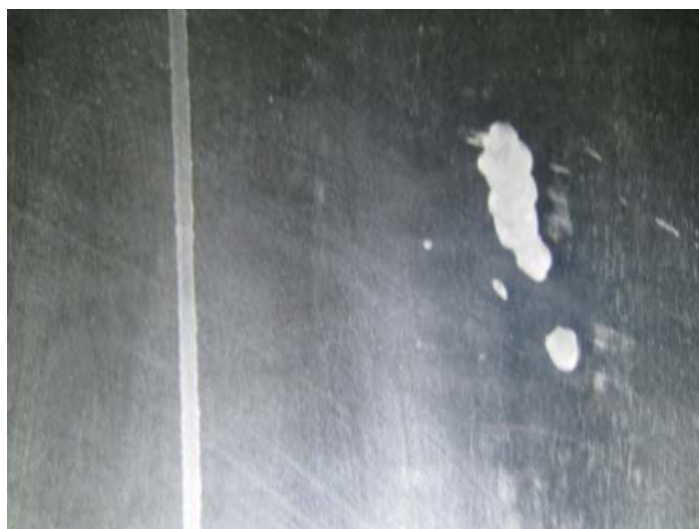
*Hot leg weld root and a base material weld repair.*

VT after pipe pickling revealed small non-documented welds on the MCL inner and outer surfaces at off-site manufacturer Fives Nordon. Non-documented welds were found on 10 out of 12 pipes with weld depths of 0-5 mm.

The reason for making the welds had been a habit to finalize small scratches and dents by welding and to re-melt MMA weld toes using a TIG welding process. TIG welding and the filler metals used were qualified for nozzles welding, but the repair welding was done without documentation (violation of RCC-M S 7120 and S 7600) and without non-conformance reporting controls. Many of these weld repairs could have been omitted, if designers would have evaluated the right repair method for each case. The company engineering and quality assurance units were probably not fully aware how the practical work was going on at the shop floor level.

Causes for the deficiencies were lack of communication between fabrication and design departments, inadequate education of welders (welding without specification and documentation), and failures in the implementation of the quality management system. These causes reflect a lack in the implementation of a nuclear safety culture.

The repair welds are not located at highly stressed areas. Pipe internal repair welds are not considered likely to have an effect on component ageing. Pipe external repair welds are considered insignificant.

fluctuations are present during operation. Some welds were removed using smooth grinding while the majority were left in the products as-is. New repairs were not needed.

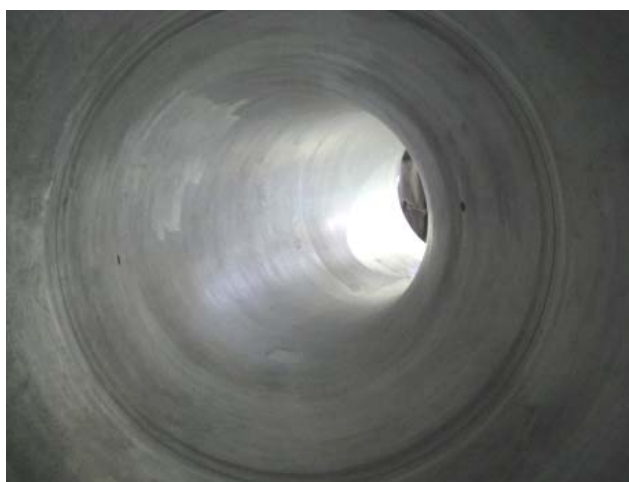
*Hot leg bend.*

Inside surfaces of induction bent main coolant line areas showed circumferential VT and PT indications after pickling right before delivery to the site. The majority of the indications were found more than a year after the induction bending and where the result of the bending process. Qualification of the induction bending process had not been completely successful and the quality of the post-bending PT tests was poor in revealing material discontinuities. Contrary to the RCC-M code, sand blasting had been used immediately before PT testing and it obviously smeared the metal surface ruining the PT testing performance.

The majority of the indications had successfully gone through two previous VT and PT tests associated with the bending process. The possibility of common cause for the indications had not been properly evaluated when some material discontinuities were found soon after bending.

Direct causes have not yet been properly evaluated by the vendor/sub-contractor. However, material discontinuities have obviously formed when at elevated temperature during induction bending. The two possible theories for the formation mechanism are: 1) metal folding or 2) grain boundary cracking.

An indirect cause was that the qualification of the induction bending process failed to identify the possibility of the development of these material discontinuities. Preparation for PT testing was unacceptably done using sand blasting, which resulted in hiding the indications and improper evaluation of the qualification pieces. Further, even if some indications were found at Mannesmann soon after bending, an enhanced test program was not started and the common cause was not properly evaluated.

Extra PT and VT were conducted by the vendor and indications that were found were repaired by grinding.

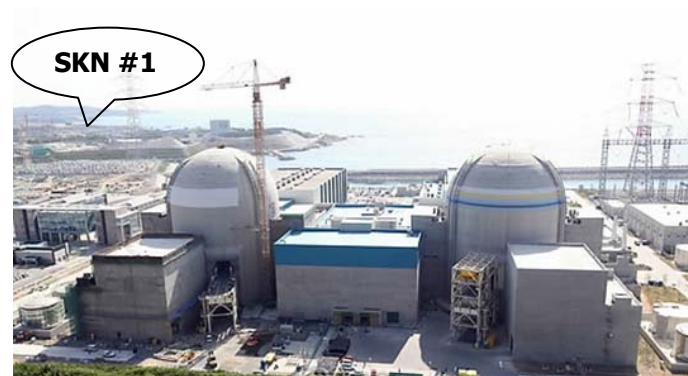
Shin-Kori Unit 1, was licensed by the Korean Government (Ministry of Education, Science and Technology) on May 19, 2010. Under a power raising test to 50% of full power, it was manually shutdown on September 14, 2010 to re-adjust the ex-core detector position. After completion of the maintenance on the ex-core detector, the plant restarted the power raising test, controlling the reactor coolant temperature utilizing the shutdown cooling system. The plant was in mode 4 with the RCS pressure and temperature at  $28\text{kg/cm}^2$  and  $145^\circ\text{C}$ , respectively. Both the shutdown cooling system and the containment spray system share the shutdown heat exchanger and are separated by the heat exchanger outlet isolation valve (CS-V033) and the containment spray isolation valve (CS-V035). CS-V033 was opened and CS-V035 was closed when the incident happened.

On September 17, at 14:17, CS-V035 opened inadvertently due to human error, and reactor coolant was sprayed into the containment through the containment spray system. The RCS experienced a severe transient; the pressure decreased rapidly from  $28\text{ kg/cm}^2$  to  $3.9\text{ kg/cm}^2$  and the temperature and water level were lowered quickly. Rapid decreases in RCS pressure and water level were identified by the MCR operators, and they carried out responsive actions in accordance with the emergency operating procedure (EOP) including stopping reactor coolant pumps (RCPs), isolation of the letdown line, and increasing the charging flow. Also, additional safety measures were taken including manual actuation of safety injection to recover the RCS inventory, and manual actuation of containment isolation to prevent any radioactive material release to the environment.

After taking a series of initial responses, the MCR operators identified that the containment spray isolation valve (CS-V035) was incorrectly in the open position and the valve was manually closed at 14:54. At this time the plant entered into a stable condition. The analyses results based on the changes of refueling water tank (RWT) level and RCS inventory showed that the amount of borated water sprayed into the containment was 423 tons.

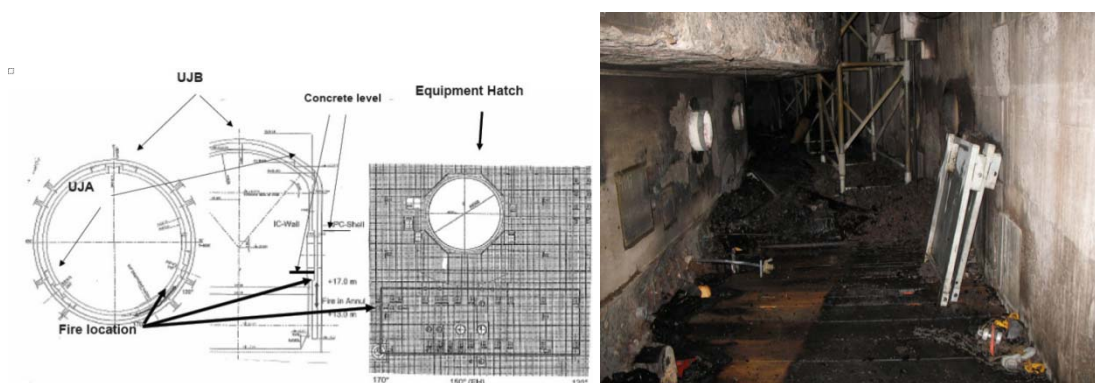
In Olkiluoto-3, on 30 July 2008 a fire initiated in the annulus space (space between the containment and reactor building wall) at level + 13 m and + 17 m, below the equipment hatch.

Initial investigations after the fire revealed damage to the concrete structures in the fire area (local spalling of protective concrete cover of reinforcement) and to the surface paint of the sleeve of the equipment hatch.
