NEA/CSNI/R(97)23

OPERATING AND MAINTENANCE EXPERIENCE WITH COMPUTER-BASED SYSTEMS IN NUCLEAR POWER PLANTS

A report by the PWG-1 Task Group on Computer-based Systems Important to Safety

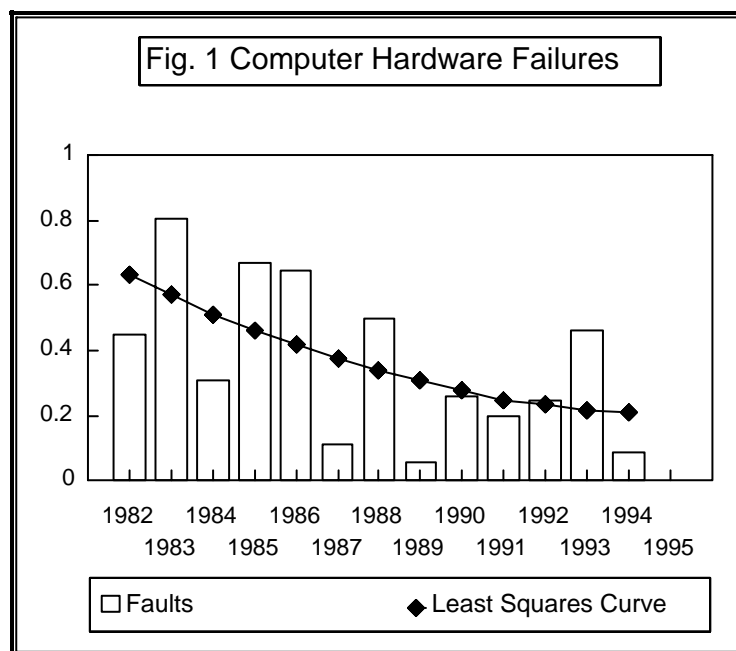
In the Canadian study [5], the computer hardware, consisting of memory, processor, interface circuit cards, internal power supply unit (PSU), and peripherals, shows a lower failure rate relative to other leading categories, most likely because of the design of the equipment, which is fully duplicated and, therefore, is fault tolerant. In other words, a single hardware fault should not affect the operation of the computer system or the plant. It was also found that the number of computer hardware faults has decreased steadily with time (Figure 1).

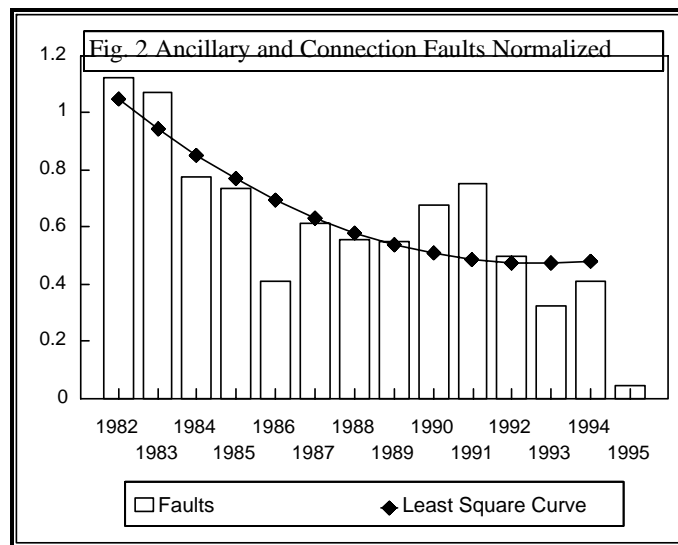
The most common hardware problem was associated with ancillary devices. This category refers to parts and sensors outside of the computer 'box'. For example, common elements in this category are sensor and relay failures. Given the nature and complexity of some of the sensors used in nuclear power plants, this finding is not unexpected. Even if utilities did not use digital computers, these sensors or their equivalent would still be required to monitor the state of the plant. Ancillary failures showed also a decreasing trend with time (Figure 2).

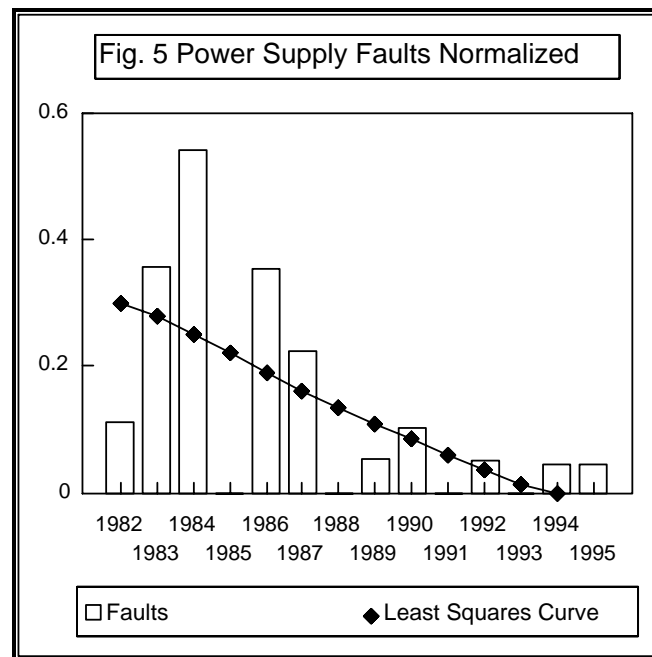
The Canadian study has shown that problems with external power supplies represent a not insignificant number of failures, despite the fact that power supplies are designed to be fully duplicated and uninterruptable. However they decreased with time as deficiencies were removed from the systems (Figure 5).

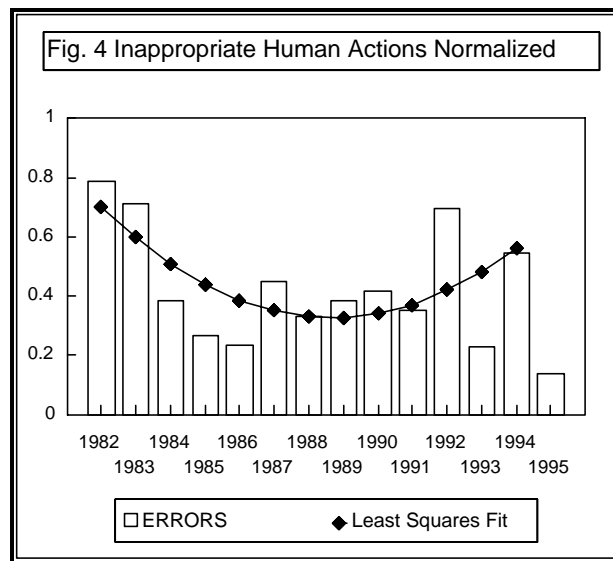
Both the U.S. study and the Canadian study indicate that the inappropriate human actions contributed to about 25% of the computer-based system events. Preliminary results from the Canadian study indicate an increase of these events in the last five years (Figure 4)

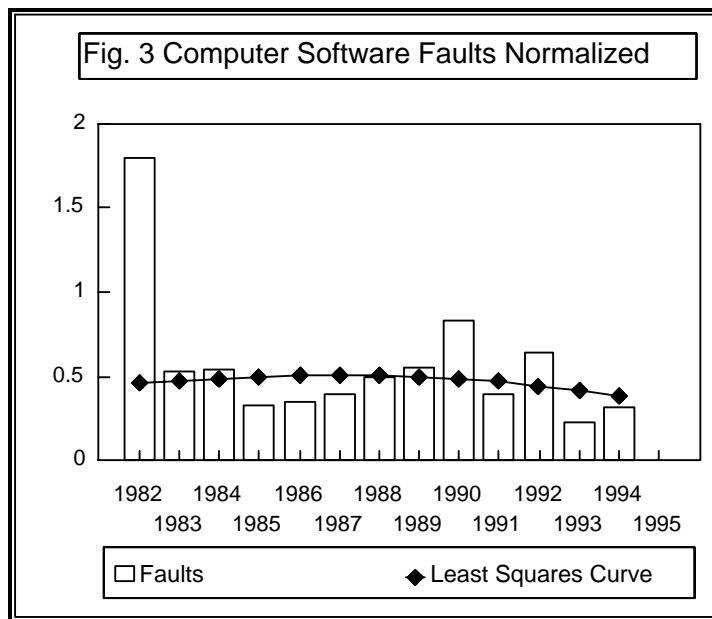
The Canadian study [5] reported that software faults represent a significant number of failures. The number of computer software faults has been decreasing slightly with time. A larger decrease in the number of failures can be expected in this area (Figure 3), because once the fault is rectified, it is permanently rectified, i.e. it should not experience wear-out trends.

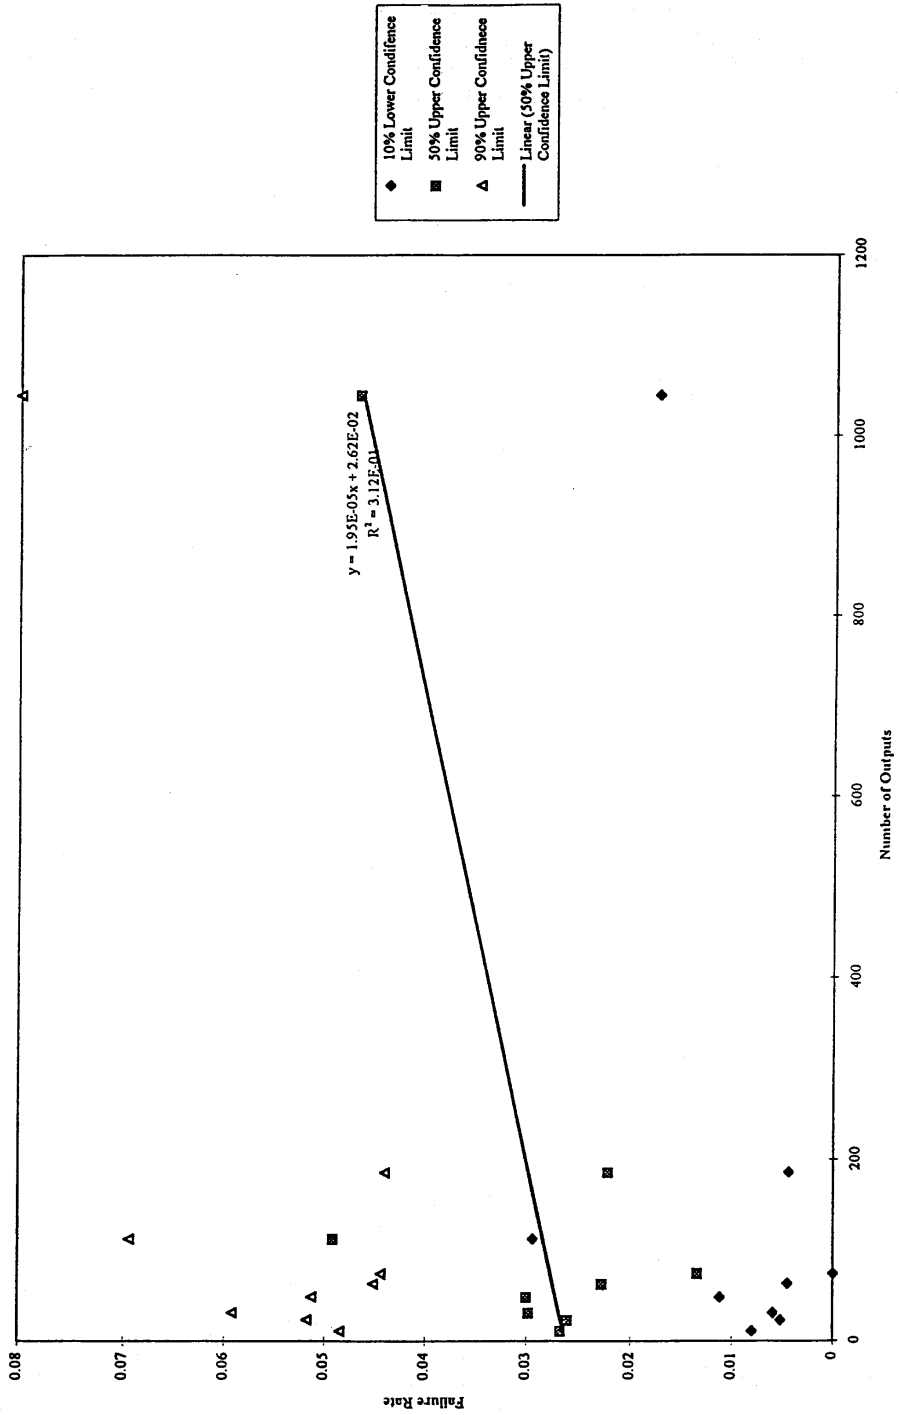
Figure 3.2 - Relationship between Failure Rate and the Number of Outputs

Figure 3.2 shows the relationship between failure rate and number of outputs. Although the trend line shows a gradually increasing trend, the fit is poor ($R^2=0.312$).

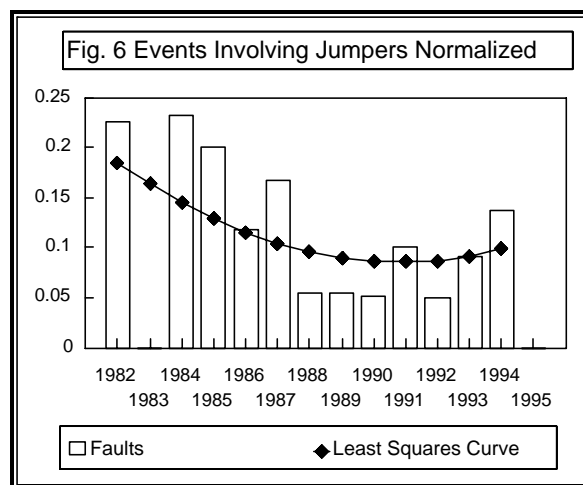
The Canadian study [5] examined the difficulties encountered with temporary modifications to the software known as "Patching" which is a modification to the software performed outside the programme, e.g. to a data table, that causes the bypass of a sequence performed by the programme. Because patches are temporary; their installation and removal is controlled by administrative procedures using a record known as a "jumper". A recent serious reactor incident at Bruce-A, in 1992 [IRS report No. 1360.00] highlighted the risk associated with patching and with the inadequate control of the software "patching" practice. In this incident, the patch was installed to force the software to operate correctly at a very low reactor power as some power sensors become irrational during reactor start-up. Because the patch was not removed when the reactor power increased the software operated incorrectly and caused a power excursion that was terminated by a reactor trip.

The number of events which involved temporary software modifications or 'jumpers' was found to decline until the late 1980s, but these are now on the increase (Figure 6). Care should be taken in drawing conclusions in this area, because of the relatively small number of failures in some years, and the random pattern of the faults.
