NEA/CSNI/R(2019)13

NEA CODAP PROJECT TOPICAL REPORT

A REVIEW OF THE "POST-1998" EXPERIENCE WITH THERMAL FATIGUE IN HEAVY WATER AND LIGHT WATER REACTOR PIPING COMPONENTS

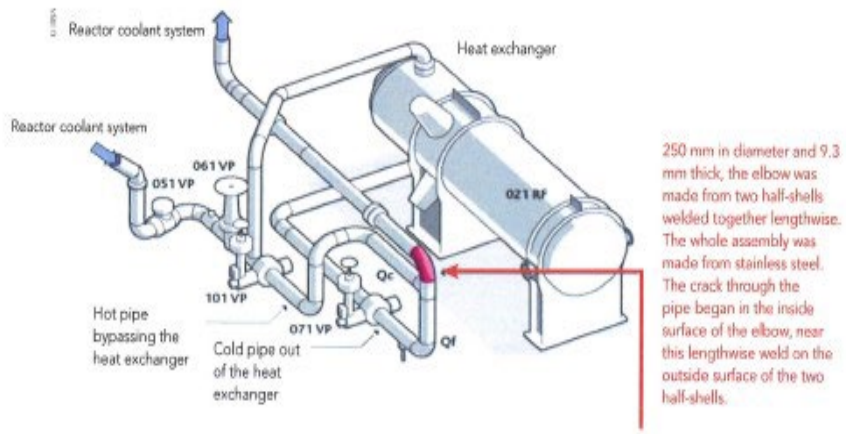
Figure 4.6. Area where the leak occurred

In the 1998 incident at Civeaux Nuclear Power Plant, reactor one was undergoing a normal shutdown when a 30 m^3/hour leak appeared in the Reactor Heat Removal System (RHRS). This system is used to remove the residual power from the reactor core. This major leak was caused by a 180 mm long crack through the pipe at an elbow immediately below a mixing tee linking a pipe (or line) carrying hot water bypassing the heat exchanger with a pipe carrying cold water coming out of the heat exchanger (Figure 4.6). ln the mixing area, the hot water was at a maximum temperature of 180°C and the cold water at a temperature of around 20°C.

From 2000, on IRSN's recommendation, EDF introduced a policy of regularly checking the replaced RHRS sections every 450 hours of operation at wide temperature differences. The 450-hour frequency was based on the first cracks observed in the RHRS circuits removed from reactor 2 at the Civaux power plant. The plant operator's initial analyses could not fully explain the location and extent of the damage observed. Furthermore, the traditional method of analysing (mechanical) fatigue could neither predict nor explain the damage observed. According to the reports on numerous inspections carried out since, TF in the mixing areas of RHRS circuits is a phenomenon that depends on many factors: the operating time at wide temperature differences, thermal and hydraulic factors (the speed and temperature of the fluid), the condition of the surface and the mechanical stresses in the different components. Because there are so many factors, understanding this type of fatigue is particularly complex.

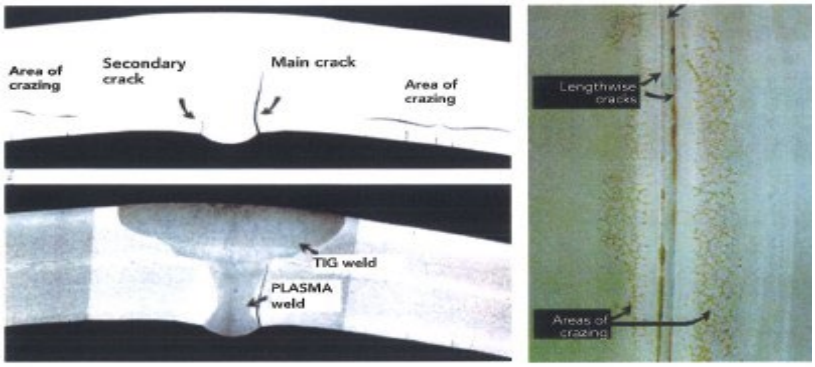
Figure 4.7. Cross-sectional view and internal view of weld bead of the cracked elbow

Inspections were carried out of the other 1 450 MW reactors (Civaux 2, Chooz B1 and B2) and then of all other reactors. The inspections were then extended to all mixing areas in the RHRS circuits of French reactors. The ultrasonic testing revealed damage to all the areas checked, prompting EDF to replace the relevant areas of the RHRS circuits in all reactors within three years. Examinations of the RHRS piping sections that had been removed revealed evidence of TF that had not been taken into account at the design stage. This phenomenon causes multiple shallow cracks, crazing (cracking of the surface) or isolated cracks starting at the base of a weld bead (Figure 4.7).

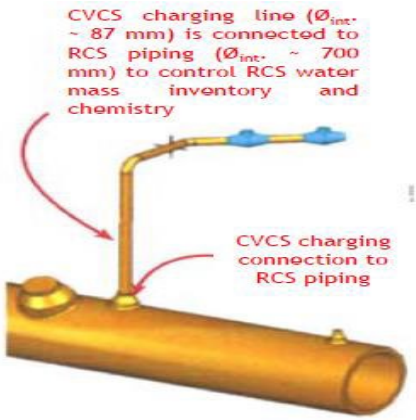
Figure 4.9. Diagram of the feed line connected to the RCS

Between 1999 and 2002, EDF appraised the sections of the RHRS circuits removed after the Civaux incident. The usage factors of these sections were also calculated on the date of removal; the usage factors were greater than one. This confirms their vulnerability to TF. However, no correlation could be established between the usage factor values and the dimensions of the cracks. ln 2001, EDF decided to investigate the possibility that there were defects in a mixing area considered "vulnerable to TF": the branch pipe of the RCS feed line (Figure 4.9).

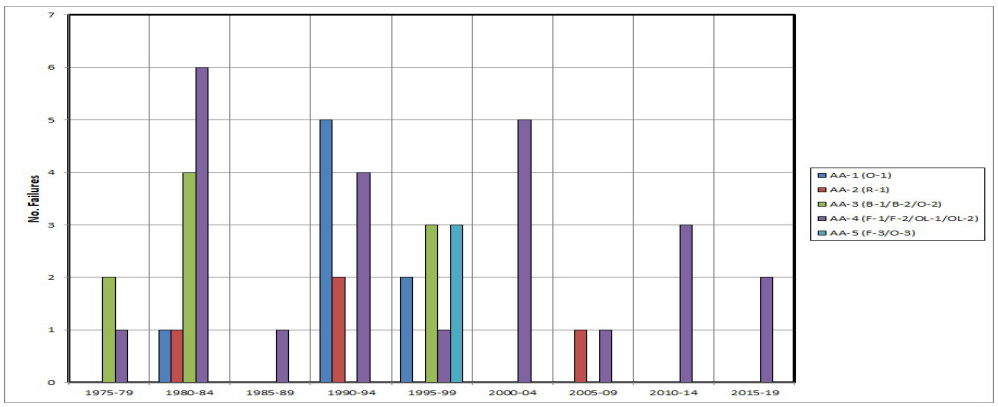
Figure 4.10. TF failures in AA reactors

Finland has four operating commercial nuclear power plants at two sites; two BWR units (OL1 and OL2) at the Olkiluoto site and two PWR units at the Loviisa site. The fifth power plant unit (OL3) is under construction. The OL1 and OL2 BWR units are of type AA-IV BWR-2500, which were designed by AA of Sweden. OL3 is an EPR (European PWR) plant unit. The two PWR units (LO1 and LO2) at the Loviisa site are of type VVER-440, which is based on a Soviet concept (Atomenergoeksport). However, the Loviisa units are designed and constructed to meet the Finnish safety requirements and conditions. The basic AA Nuclear Steam Supply System (NSSS) design of the OL1 and OL2 BWR units differs in many respects from the NSSS design by General Electric. OL1 and OL2 are essentially identical to Forsmark-1 and Forsmark-2 in Sweden. The AA-specific thermal fatigue-induced damage experience is summarised in Figure 4.10.

An example of recent TF experience in OL1 and OL2 involves the discovery of several 2 to 5 mm deep cracks on the inner surface of the main feed-water piping. The cracks were detected during respective refuelling outages in 2014. These cracks were located in the base metal of the FW/RHR mixing tees. The feed-water system of the AA-IV design consists of two main header pipes, each with a RHR branch connection. The RHR system is basically always in operation. When the reactor is in hot standby, there is no preheating of the feed-water. To keep the RPV water level within the normal allowable range, smaller amounts of cold water are added through one of the FW lines. Thus, the ~20°C feed-water and 280°C RHR water mix and create cyclic temperature fluctuations in the large-diameter FW pipe upstream the tee (Figure 4.11).

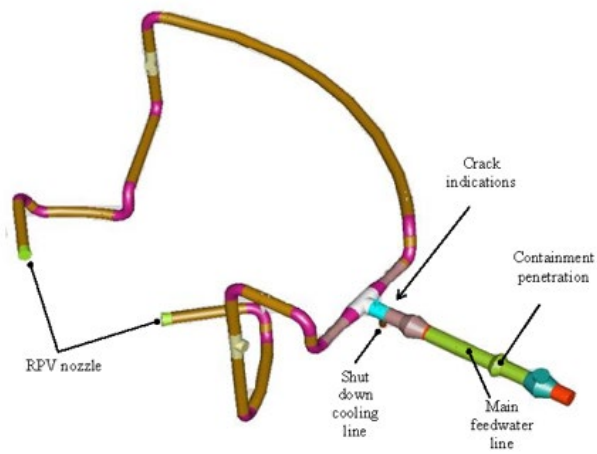
Figure 4.11. Location of the crack indications in FW/RHR mixing tees

Cracks in the mixing tees in OL1 and OL2 were first discovered in the early 1980s and in response to these discoveries the mixing tees in both units were replaced in 1986. To minimise thermal fluctuations and in response to this operating experience, the original

design of the mixing tee was improved by installing sparges (or static mixers) to improve the mixing of the fluids and to create a more uniform temperature distribution.[9]

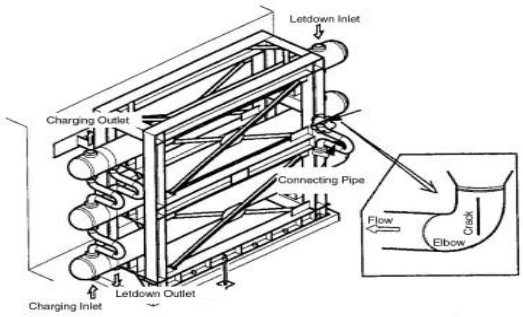
Figure 4.16. Location of primary coolant leakage

- Tsuruga-2 (4-loop PWR), July 1999. A primary coolant leak was detected at 6.05 am when fire alarms in the passage outside SG compartments C and D were activated. At the same time, another alarm showed a high level in the containment sump followed by an increase in charging flow and an increase in the reading of the containment vessel particulate radiation monitor. A controlled shutdown was started at 6.24 am. When cold shutdown conditions had been reached, radiation levels inside containment began to fall. Engineers entered containment at 18.45 and found a leak at the outlet of one of the regenerative heat exchangers of the CVCS. The leak was stopped by closing an isolation valve and upon removal of insulation from the pipework a through-wall crack was found on an elbow joint (Figure 4.16).

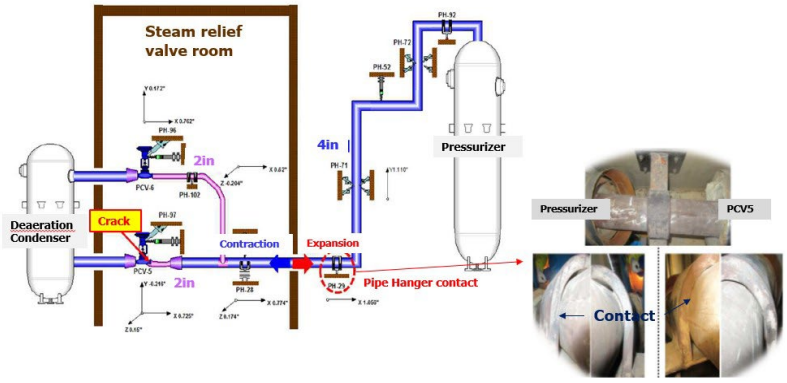
Figure 4.17. Pressuriser steam relief valve schematic diagram

During a planned outage at Wolsong unit 4, a through-wall flaw was found on a welded connection of the pressuriser steam bleed valve. On 17 June 2014, at around 10:30am, while the unit was on guaranteed shut down for a planned maintenance outage, a fine through-wall crack was found at the pressuriser side of the welded connection of the pressuriser steam bleed valve (63332-PCV5); see Figure 4.17. The field investigation

revealed that the pipe was locked in because a pipe hanger (PH-29) had not been installed correctly as designed and the operation of the pressuriser steam bleed valve (63332-PCV5) generated repeated thermal loading to the restrained pipe, which caused corrosion-fatigue cracking (CFC) on the weld zone and ultimately through-wall leakage.

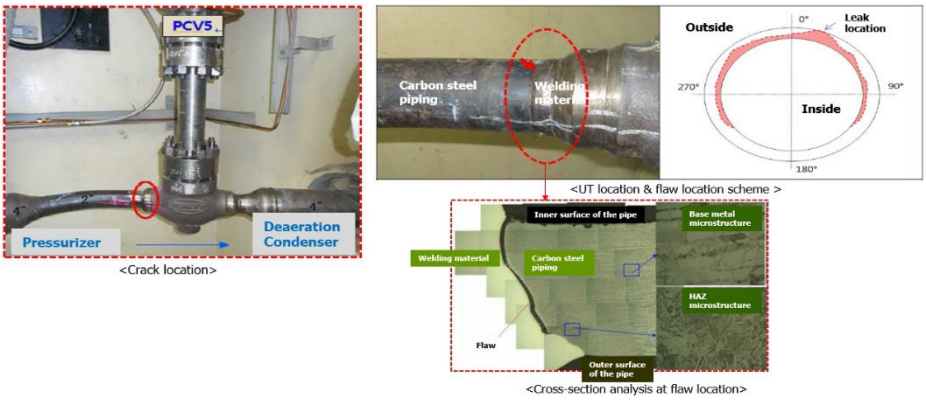
Figure 4.18. Fracture surface analysis results

The fracture surface and cross-section analysis showed that the flaw morphology was a typical corrosion-fatigue crack (Figure 4.18). The key damage mechanism was determined to be circumferential CFC, which grew from the inside to outside surface of the welded connection along the boundary between the base and welding metals due to extended exposure to a corrosive environment coupled with the repeated thermal loading from operation of the valve as well as the tensile stress caused by the interference with some of the pipe hanger.

The evaluation of the leak rate from the fine through-wall crack showed that the leaked coolant (about 0.9 kg) was properly recovered as the plant proactively sealed the potential leak points when the increasing trend of the reactor building tritium concentration was noticed. Since there were no meaningful changes in terms of radioactivity level including the tritium concentration in reactor building and the amount of effluent release from the vent, it was concluded that the leakage from the through-wall crack on the welded

connection of the pressuriser steam bleed valve did not cause any safety concerns such as radiological leakage to the environment.

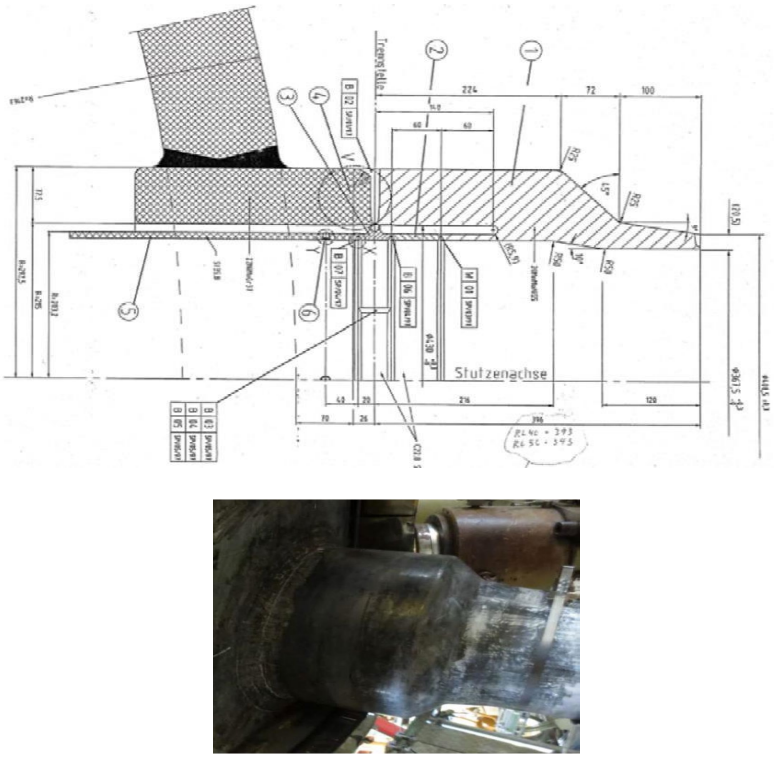
Figure 4.20. SG feed-water nozzle thermal sleeve design

An example is the ultrasound inspection of the thermal sleeve at the SG nozzle (Figure 4.20). The location where the thermal sleeve connects to the nozzle has a high usage factor. Even if the thermal sleeve has no pressure-retaining function, a NDE was carried out to rule out the presence of possible crack initiation. This examination was carried out during the outage of 2018.

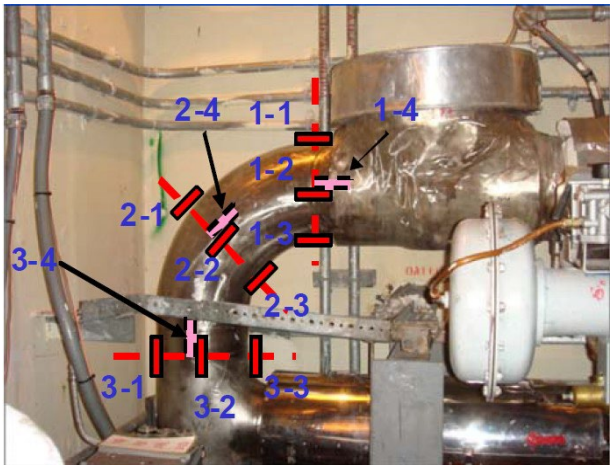
Figure 4.22. The positions of the strain gauges and thermometers

At the end of 2009, research began on the Maanshan Nuclear Power Plant's TF issue. In April 2011, hot and cold mixed T pipe thermal fatigue monitoring equipment was set up at the T pipe at the exit of the RHR heat exchanger at Maanshan unit two. Figure 4.22 shows the installation positions of the 12 strain gauges and 12 thermometers, which were installed at 4 different positions on 3 sections. Figure 4.23 shows the stress-over-time and Figure 4.24 is a flow chart that uses the measured data to analyse the degree of TF (the maximum stress amplitude value of > 28.2 ksi is per ASME Section III, Appendix I, Figure A.1. The maximum stress amplitude threshold of > 13.6 ksi is per ASME Section III, Appendix I, Figure A.2.).

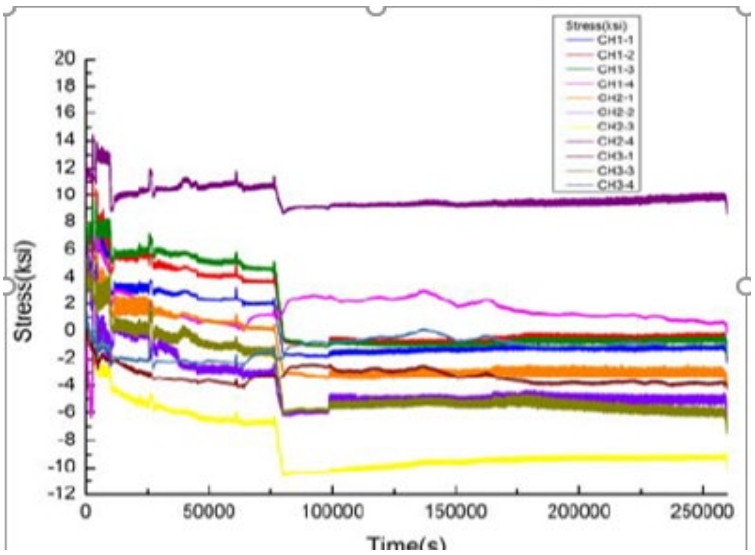
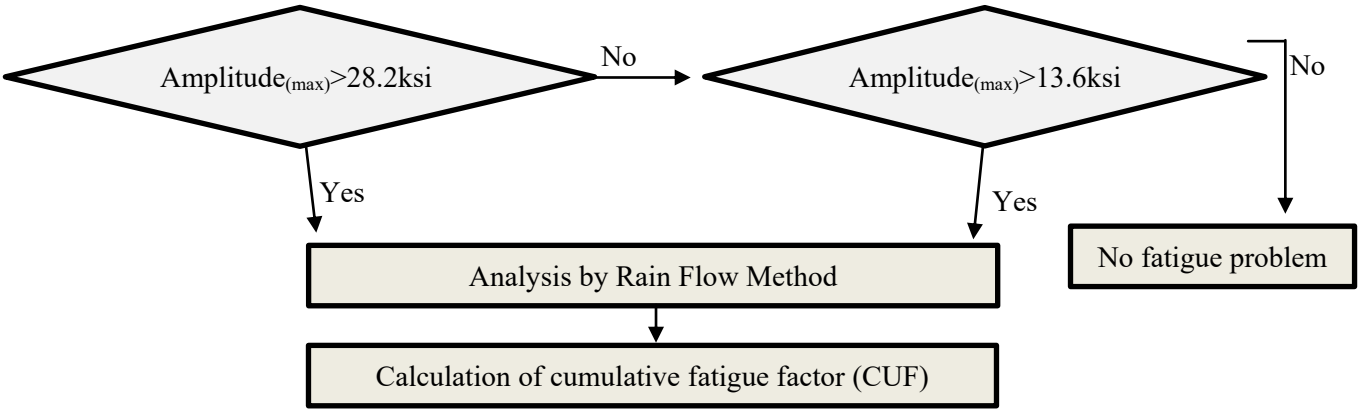
The strain value measured by the strain gauge is converted into a stress value, thereby determining the maximum stress amplitude. If the maximum stress amplitude is greater than 13.6 ksi, the CUF should be calculated by the "rain flow method" (RFM) as described in ASME Section three, Appendix I, Figures I-9.2.1 and Figures I-9.2.2 (the RFM is used in the analysis of fatigue data to reduce a spectrum of varying stress into a set of simple stress reversals. It allows the application of Miner's rule to assess the fatigue life of a structure subject to complex loading.) If the maximum stress amplitude is less than 13.6 ksi, there is no fatigue problem. Because maximum stress amplitude at the T pipe at the exit of the RHR heat exchanger at Maanshan unit 2 was lower than 13.6 ksi, it was determined that there was no TF issue in that pipe.

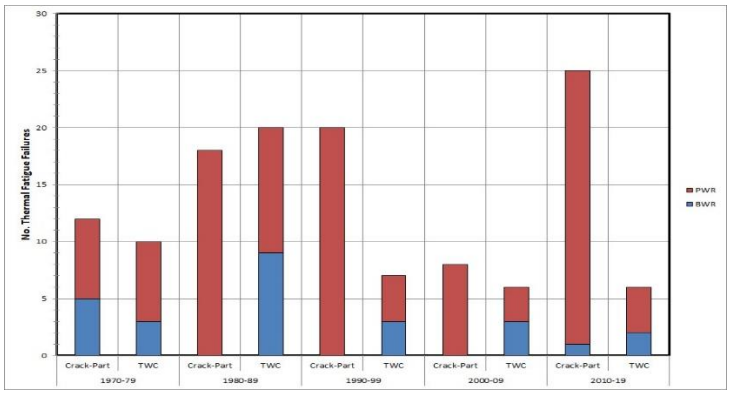
Figure 4.25. The US TF operating experience

The US operating experience with TF is summarised in Figure 4.25. Thermal stratification was first identified in 1977 as the root cause for ASME III Code Class 2 feed-water nozzle cracks which occurred at a number of PWR plants. The next industry-wide thermal stratification concern arose at Farley unit 2 in late 1987, because of an unisolable primary system water leak. Subsequently, reports from foreign reactors (e.g. Tihange unit 1 and Genkai unit 1) described similar events. Table 4.3 summarises the NRC regulatory bulletins and information notices related to thermal stratification. References [11] [29] and [30] provide more detailed technical information on TF experience for the period from 1970 to 2000.
