**NEA/CNRA/R(2012)2**

**NUCLEAR ENERGY AGENCY  
COMMITTEE ON NUCLEAR REGULATORY ACTIVITIES**

**First Construction Experience Synthesis Report  
2008-2011**

**Working Group on the Regulation of New Reactors (WGRNR)**

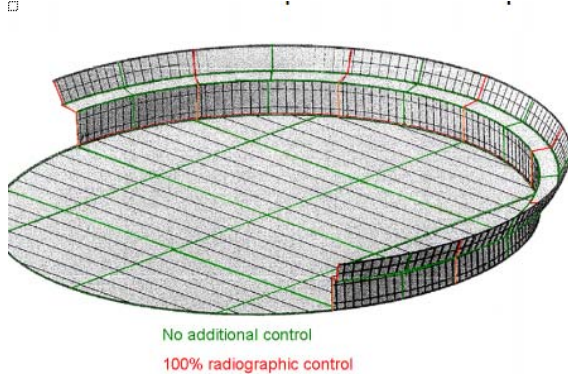
In June 2008 at Flamanville-3 the licensee, after several questions raised by ASN about the welding activities on the liner, decided to stop all welding activities. That same month an inspection by ASN found that the welding processes used were not permitted by the construction code. ASN required a justification for the lack of compliance with the construction code to ensure the quality of the liner in such conditions.

In the following months ASN detected an excessive number of repairs (especially on the reactor building basemat area), they found inadequate consideration of adverse environmental conditions (water, wind, etc.), and required the licensee to demonstrate the quality of the liner welds and to define preventive actions to reduce the repair or rework rate of welds. As a response to this, the licensee submitted a report that concluded that the defects were due to gas cavity, inclusion, and only 4% of the defects due to lack of fusion, wormhole, etc. It also indicated that the repair rate in the reactor basemat area was between 13% to 34% while this same figure in the prefabrication area was between 5% and 15%.

The direct cause of these events was poor manual welding, worsened due to the bad weather conditions. The automatic process was not possible in the environmental conditions of the building site.

The safety consequence of these deficiencies in the liner welds was the loss of the pressure boundary of the containment.

The main actions taken by the licensee were to develop suitable protection of the welding areas to improve the environmental conditions, reinforcing the control of its subcontractors and performing a 100% radiographic test of the liner welds.

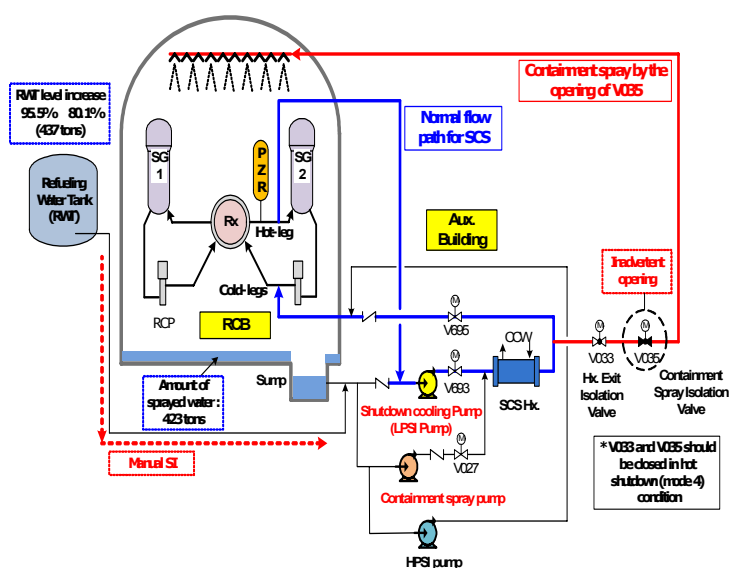
On September 17, at 14:17, CS-V035 opened inadvertently due to human error, and reactor coolant was sprayed into the containment through the containment spray system. The RCS experienced a severe transient; the pressure decreased rapidly from  $28\text{ kg/cm}^2$  to  $3.9\text{ kg/cm}^2$  and the temperature and water level were lowered quickly. Rapid decreases in RCS pressure and water level were identified by the MCR operators, and they carried out responsive actions in accordance with the emergency operating procedure (EOP) including stopping reactor coolant pumps (RCPs), isolation of the letdown line, and increasing the charging flow. Also, additional safety measures were taken including manual actuation of safety injection to recover the RCS inventory, and manual actuation of containment isolation to prevent any radioactive material release to the environment.

After taking a series of initial responses, the MCR operators identified that the containment spray isolation valve (CS-V035) was incorrectly in the open position and the valve was manually closed at 14:54. At this time the plant entered into a stable condition. The analyses results based on the changes of refueling water tank (RWT) level and RCS inventory showed that the amount of borated water sprayed into the containment was 423 tons.

During the event, the major plant safety systems including the emergency diesel generator (EDG) and containment purge isolation were actuated as designed. As a result of the event, most of the Structures, Systems, Components (SSCs) inside the containment were affected by the sprayed borated water; especially the reactor cavity and the containment floor level were flooded.

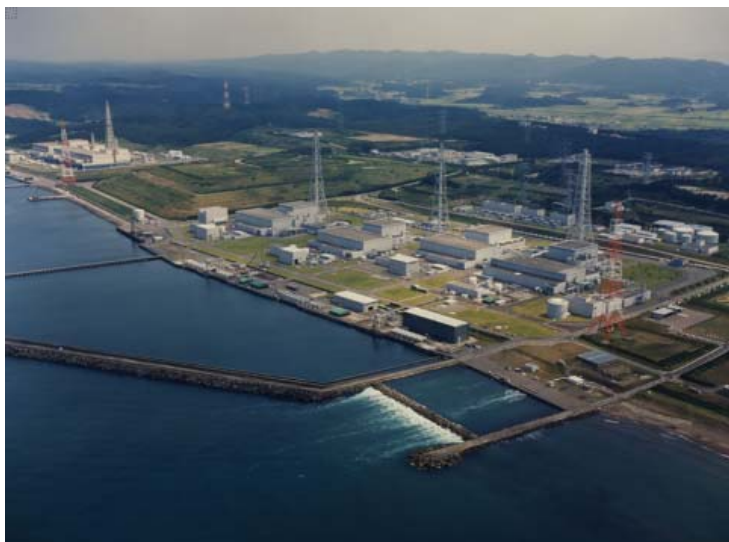
- *Event 55. Kashiwazaki-kariwa.2007.Japan.*

A seismic event of 6.8 on the Richter scale occurred 16 km from the site at 10:13 A.M. on 7/16/07. A small fire occurred in an electrical transformer in the switchyard of unit 3. It took two hours for the fire to be extinguished. About 315 gallons of radioactive contaminants leaked from Unit 6 and reached the Sea of Japan (1621 nano-curies total). The primary cause of this deficiency was determined to be an earthquake greater or comparable to SSE.
