NEA/CSNI/R(97)23

OPERATING AND MAINTENANCE EXPERIENCE WITH COMPUTER-BASED SYSTEMS IN NUCLEAR POWER PLANTS

A report by the PWG-1 Task Group on Computer-based Systems Important to Safety

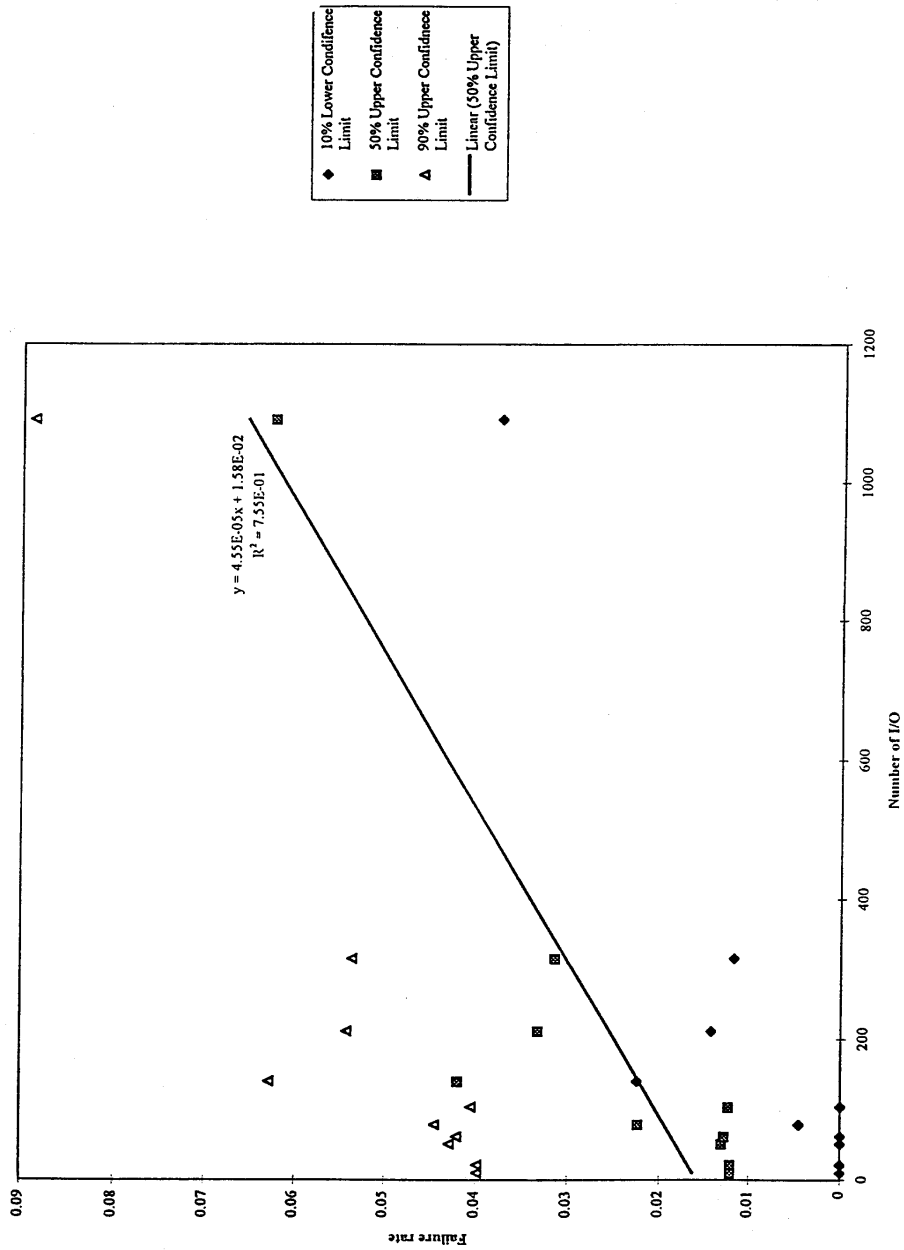
Figure3.3 - Relationship between Failure Rate and the Number of Inputs and Outputs

Figure 3.3 plots failure rate against the sum of inputs and outputs. Again, there is a clearly increasing trend but with a fit better than that of Figures 5.1 and 5.2 ($R^2=0.755$).

The best straight line fits are shown by Figures 3.3 and 3.4. Figure 3.4 is, however, based on the subset of data for which information on programme size is available in terms of relay coils.

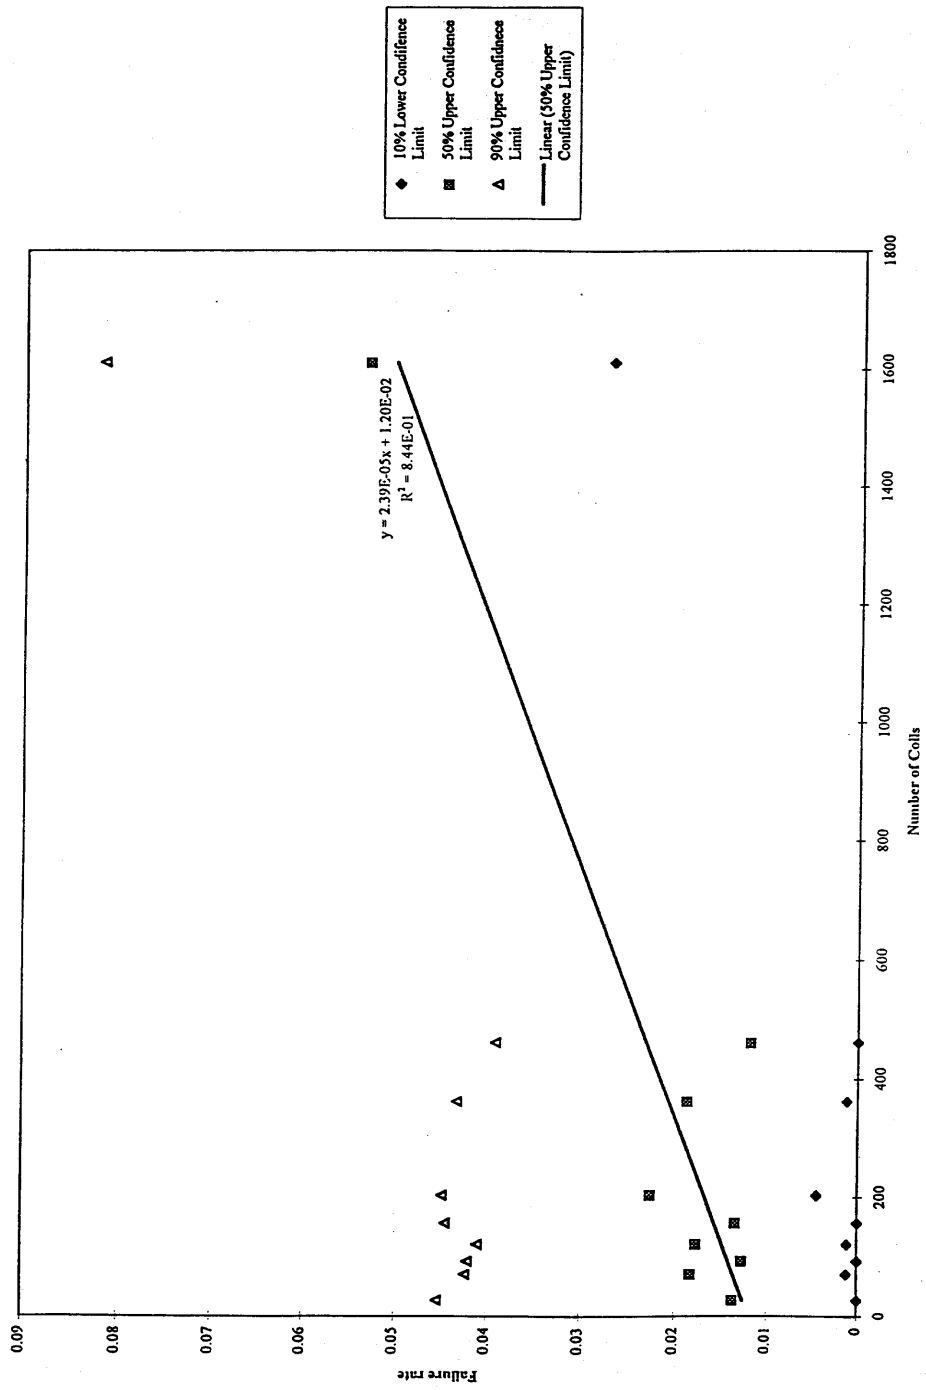
Figure 3.4 - Relationship between Failure Rate and the Number of Coils

The majority of the data collected recorded programme size in terms of the number of ladder logic relay coils. For these systems, the relationship between failure rate and programme size is shown in Figure 3.4.

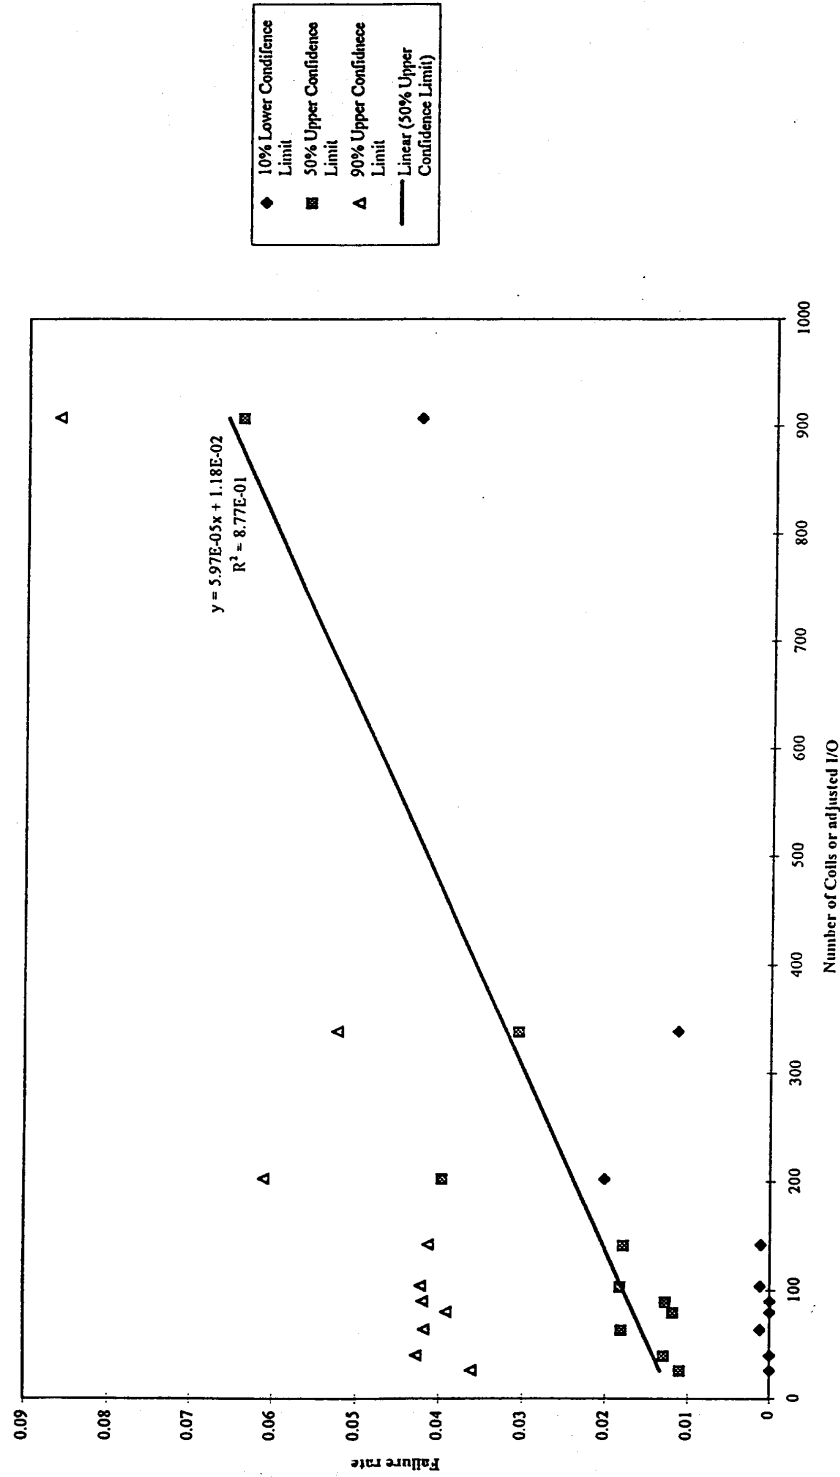
Figure 3.5 - Relationship between Failure Rate and the Number of Coils or Adjusted I/O

In order to provide additional data, for the systems for which programme size was measured in some way other than by coils, an estimate of the equivalent number of coils was made from the total I/O count and the above average ratio. The results are shown in Figure 3.5.

It can be seen from Figure 3.5 that there is an improved straight line fit to the data over that using either the I/O count alone or the number of coils alone ($R^2 = 0.877$).
