**NUCLEAR ENERGY AGENCY
COMMITTEE ON NUCLEAR REGULATORY ACTIVITIES**

Heavy Load Accidents in Nuclear Installations

Working Group on Operating Experience (WGOE)

NEA/CNRA/R(2017)4

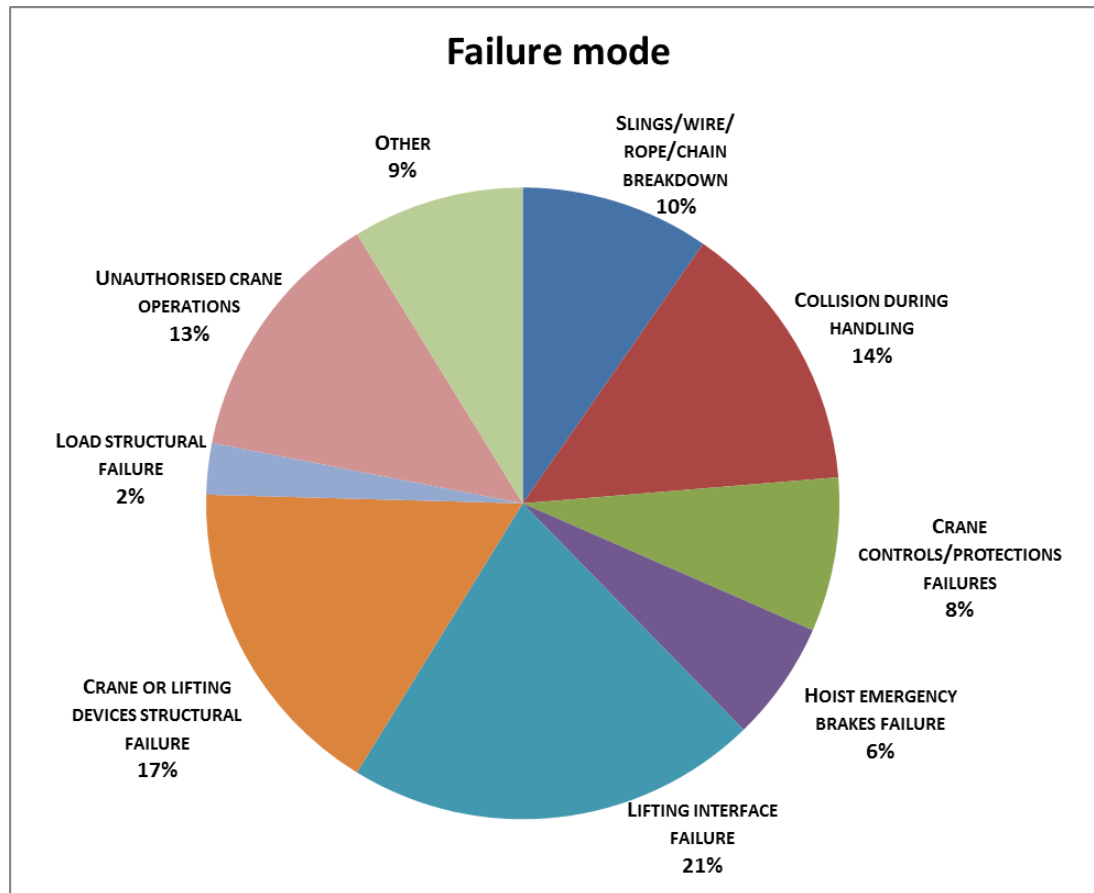
Figure 2: Distribution of events by failure mode

The “Lifting interface failure” (24 reports) is dominated by events with containers and nuclear fuel assemblies. In most events, the gripper disengaged from the fuel assembly or container, for different reasons.

The “crane or lifting devices structural failure” (19 reports) includes many events revealed during engineering design reviews or crane tests, which explains why in most cases no load was involved, and only potential consequences are described. However, this group includes also the actual collapse of the heavy lifting system during lifting of the main generator stator at Arkansas Nuclear One site in 2013.

Collisions during handling (16 reports) occurred mostly on nuclear fuel handling, and nearly always the direct cause was an operational error.

There are cases where misunderstandings among staff led the crane operator to start handling loads in unsafe conditions, or with loads exceeding the maximum allowable weight. These reports make up most of the “Unauthorised crane operations” category (15 reports).

Out of the reports classified as “Slings/wire/rope/chain breakdown” (11 reports), 3 involved containers and 3 involved fuel assemblies. In some cases the breakdown was caused by fatigue (sometimes linked to chaffing or twisting), or by the use of improper, unqualified slings.

In the case of the group “Load structural failure” (3 reports), all 3 events involved nuclear fuel. In one case a rupture in the fuel element’s central-water channel caused the fuel element to separate in 2 parts with the fuel assembly upper tie plate and the fuel channel remaining in the gripper.

Eight different main failure modes have been identified, covering more than 90% of the events.
