**NUCLEAR ENERGY AGENCY
COMMITTEE ON NUCLEAR REGULATORY ACTIVITIES**

Third Construction Experience Synthesis Report

COMMITTEE ON NUCLEAR REGULATORY ACTIVITIES (CNRA)

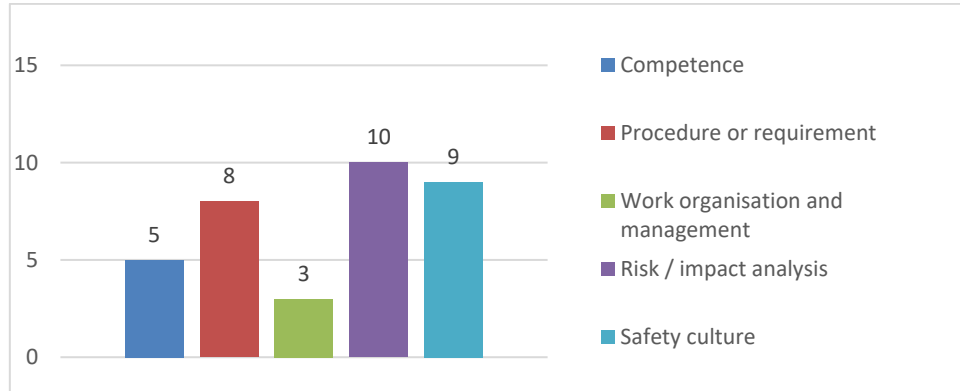
Figure 3.2 shows the number of events by cause of event. Most of the causes are related to human factors. Ten events show a deficiency in the risk or impact analysis process. This process is identified in many events because it is a large process with the objective of preventing events from happening. It can concern component failure, but also activities and processes. In addition, nine events highlight a potential lack of safety culture in the staff of stakeholders (e.g. licensee, vendors, subcontractors). Eight events highlight unsuitable procedures or requirements, and five events highlight competence issues. Finally, management and work organisation has been identified as a root cause for three events.

Figure 3.2. Number of events per each identified root cause of event.

¹. Please note that this categorisation of mechanical events is different from the categorisation presented in Figure 3.2. This paragraph contains events that have causes relating to mechanical components and phenomena. Figure 3.2, on the other hand, includes a wider set of events, including events affecting mechanical components, but not necessarily caused by mechanical components.

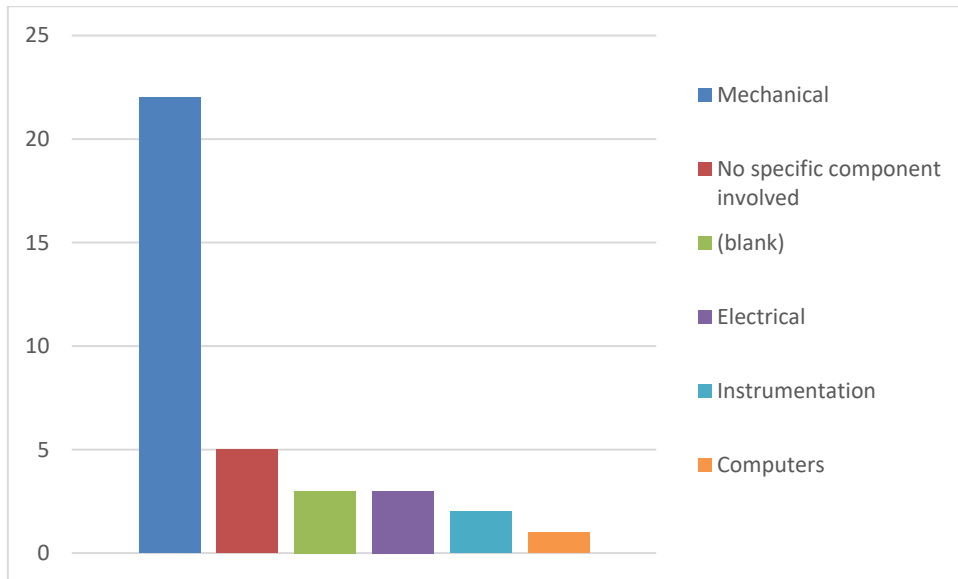
The number of events that affected each component type is shown in Figure 3.3. Events affecting mechanical components are by far the most common: 22 events affected mechanical components. Five events have no specific component affected and in three events the participants did not specify the affected component. Electrical components, instrumentation and computers were affected by three, two and one event, respectively.

Figure 3.3. Number of events per each affected component identified.

As can be seen in Figure 3.3, most of the events are related to mechanical components. It is worth considering why so many construction events are related to mechanical components. It is possible that mechanical components are more prone to construction events and new build regulators should therefore pay greater attention to them. On the other hand, it may be that the relatively high number of events is simply due to the large number of mechanical components present in a nuclear power plant.

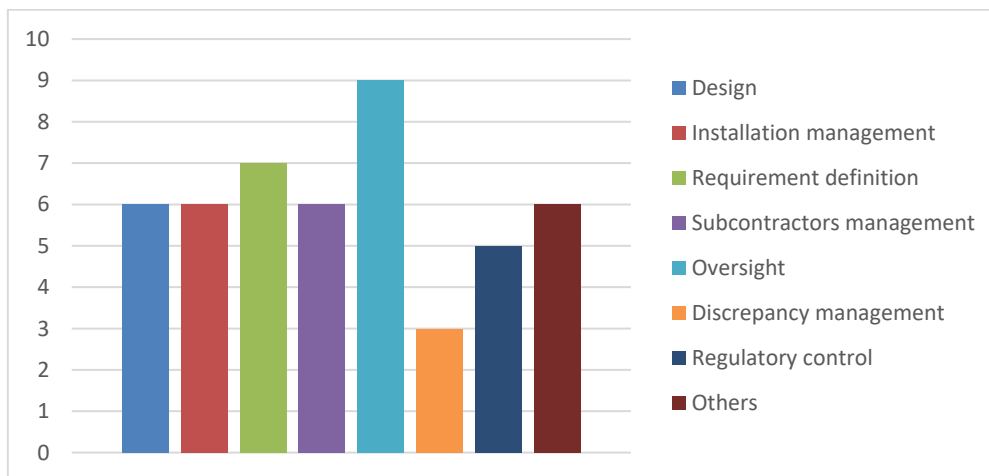
The lessons learnt listed from the events varied and were aggregated based on similarities. The share of events by aggregate category is shown in Figure 3.6.

Figure 3.6. Share of events by each aggregate lesson learnt category.

Figure 3.6 shows lessons learnt from the events by aggregate category. The lessons learnt were often vague. Therefore, the WGRNR should encourage members to pay attention in examining and writing the lessons learnt with adequate precision. However, it should also be noted that many of these events could have been avoided with more effective oversight and better project management (installation management, subcontractors management, etc.).
