NEA/CSNI/R(2014)6

**NUCLEAR ENERGY AGENCY  
COMMITTEE ON THE SAFETY OF NUCLEAR INSTALLATIONS**

**CODAP TOPICAL REPORT**

**Flow Accelerated Corrosion (FAC) of Carbon Steel & Low Alloy Steel Piping in Commercial Nuclear Power Plants**

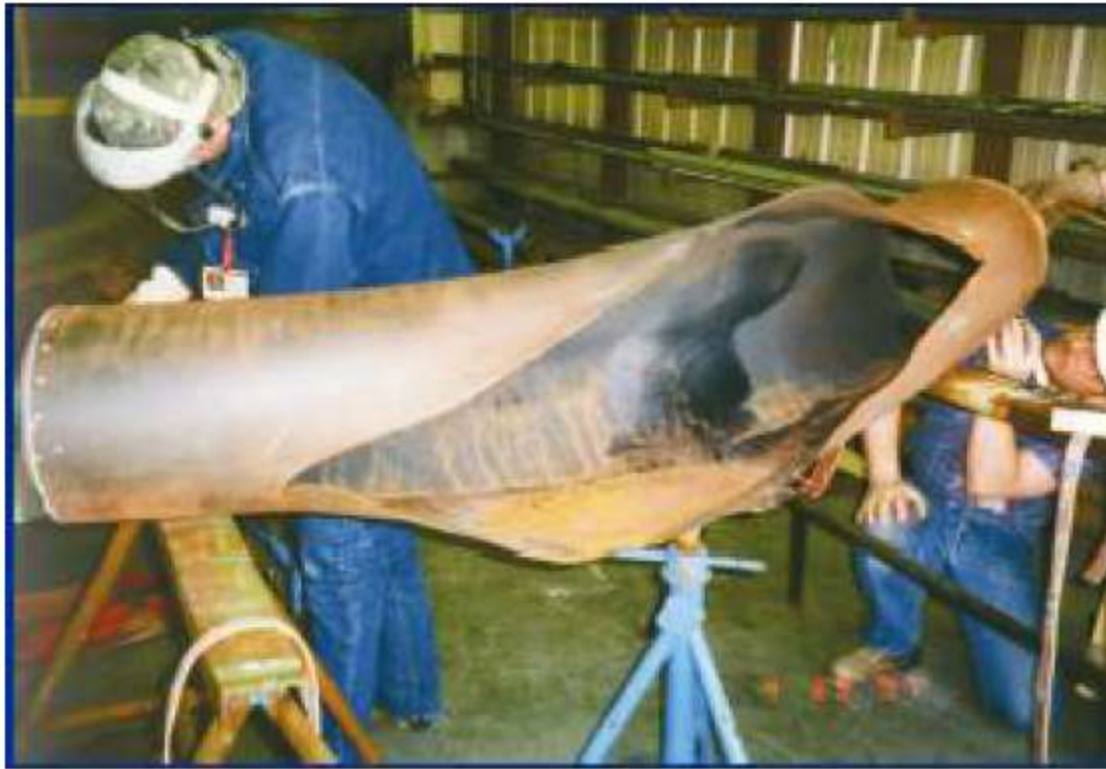
CODAP EVENT ID 2506: On April 7, 1997, a DN300 extraction steam line to a feedwater heater ruptured in the turbine building. The rupture occurred in the 4<sup>th</sup> stage extraction steam piping, in a DN300 sweep elbow (radius equal to five times the pipe diameter). When operators heard a loud noise from the turbine building, the reactor was manually tripped. The rupture (estimated by the plant owner to be approximately 0.9 m long) occurred at the outer edge of a large radius bend in the extraction steam line; see Figure A-2.

**Figure A-2: Ruptured Long-Radius Elbow**

The failure of the piping in the fourth stage extraction steam system was most likely due to flow accelerated corrosion. The design conditions of the fourth stage extraction system were 300 psig/425°F and the system was composed of primarily 12-inch diameter piping fabricated from A 106B carbon steel with a nominal wall thickness of .375 inches. The "fishmouth" break, which occurred, was approximately 4 feet long by 1 foot wide, and it was postulated that an approximately 2 - 4 inch wide by 4 foot long section of pipe was below minimum wall thickness before the rupture. The failure location occurred on what is known as a "large radius elbow." The as-found readings on the failed pipe revealed a minimum wall thickness of the rupture seam of .054 inches, whereas the minimum allowable pipe thickness was 0.126 inches. The failure location was modelled in the licensee's erosion/corrosion programme but the actual wall thickness had never been measured using non-destructive examination techniques. The licensee had relied on CHECWORKS to monitor the condition of the large radius elbows in the extraction steam system. The CHECWORKS methodology had predicted a lower wear rate on the large radius elbows relative to other potential wear locations within the fourth stage extraction steam system.

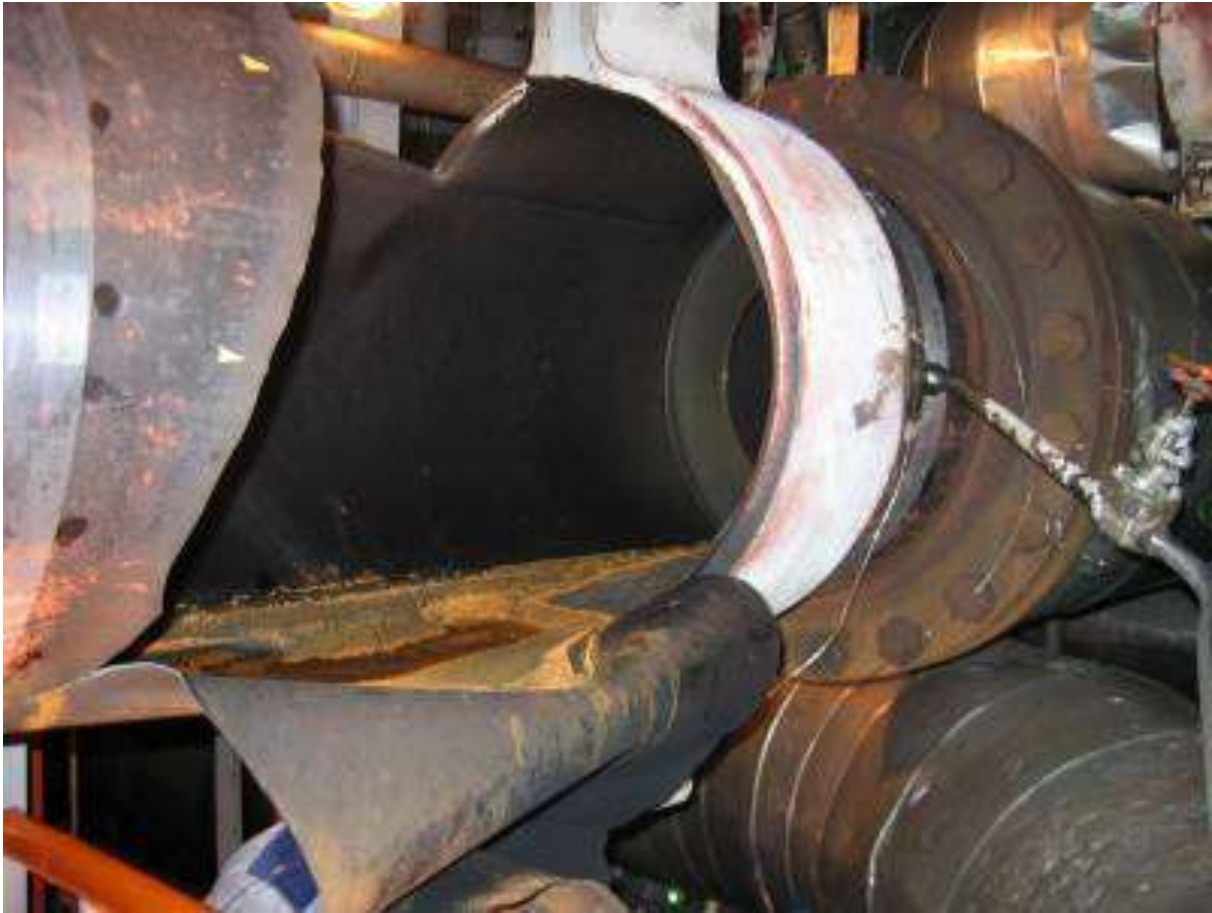
**Figure A-3: Mihama-3 Condensate Pipe Failure**

According to the KEPCO Accident Report, it was estimated as a result of the situation survey on the spot that high temperature water flowed out from the opening and then flowed down from the second floor to the first floor through the stairs and openings, and finally flowed into the turbine sump. With regard to steam blown out from the opening, it is estimated that the steam rapidly permeated almost the entire area of the turbine building immediately after the pipe rupture, and intruded into some portions of the control building, and the intermediate building adjacent to the turbine building.
